Hazardous Materials Technical Report Oregon Department of Transportation

Appendix B. Field Survey Photo Log

Hazardous Materials Technical Memorandum, I-5 Rose Quarter Improvement Project Site Location: Portland, Oregon PHOTOGRAPH LOG

Project No. 60537425

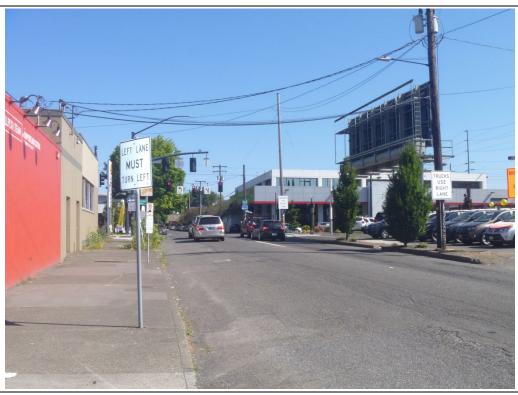
Photo No. Date: 7/25/17 4 **Direction Photo** Taken:

View of I-5 to the west and downgradient of the building at Site 18 from NE Weidler Street. This Site of Concern is within the Project Area and is ranked high priority. This building is proposed to be removed.

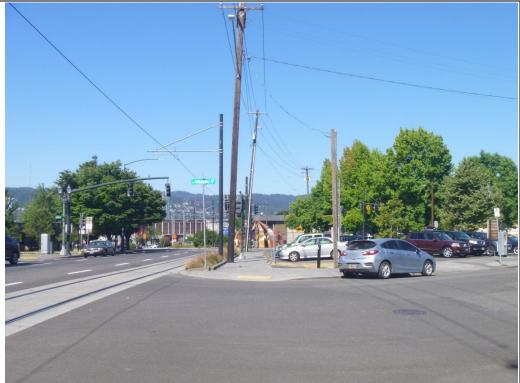
Photo No.Date:77/25/17Direction PhotoTaken:

View of N Wheeler Avenue and N Broadway in background and Site 17, "Paramount Apartments" (253 N Broadway) beyond. This Site of Concern is within the Project Area and is ranked high priority.

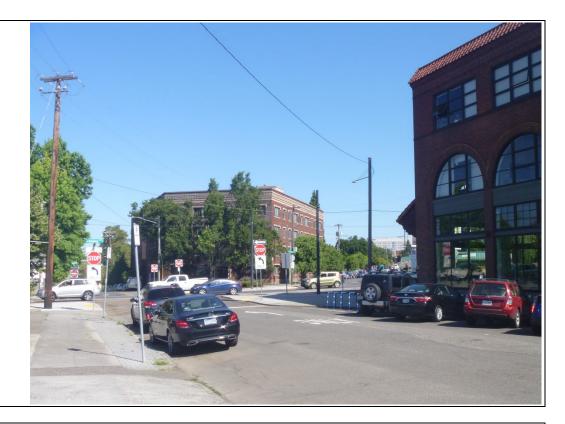
Photo No.Date:87/25/17Direction PhotoTaken:

View of Site 14, "Williamsen & Bleid" (1835 N Flint Avenue and 270 N Hancock) along N Flint Avenue. View of unidentifiable 55-gallon drums at exterior property. This area is in the northern portion of the ODOT-proposed Hancock/Dixon cover. This Site of Concern is within the Project Area and is ranked medium priority.

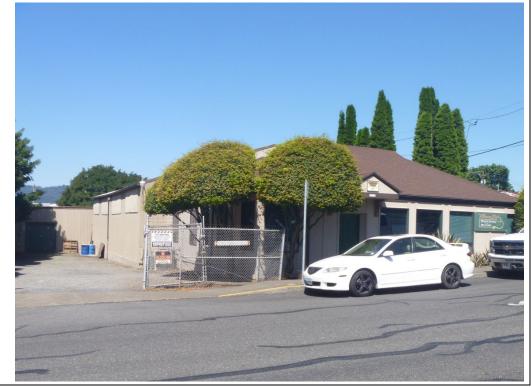
Photo No.Date:97/25/17Direction PhotoTaken:

View of Site 16, "PPS Fleet Garage Multnomah Co Fac & Prop Blanchard Bldg" (301 N Dixon Street). Former potential transformer location observed along exterior building (out of photo, to the left). This Site of Concern is within the Project Area and is ranked medium priority.

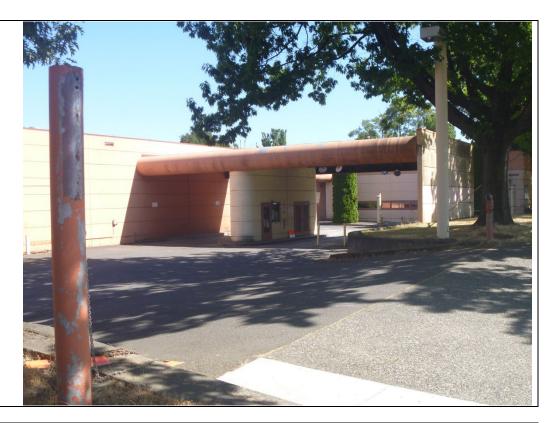
Photo No.	Date:
10	7/25/17
Direction Photo	
Taken:

View of UST fill ports at the Site 16. This Site of Concern is within the Project Area and is ranked medium priority.

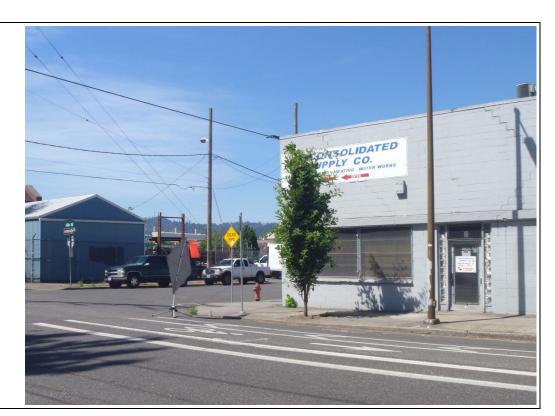
Photo No.Date:147/25/17Direction PhotoTaken:

View of Site 42, a vacant/abandoned building at the corner of N Broadway and N Vancouver Avenue (1626 N Vancouver), adjacent to the west (left) of the ODOT-proposed Hancock/Dixon cover. This photo was taken within the Project Area and is ranked moderate priority.

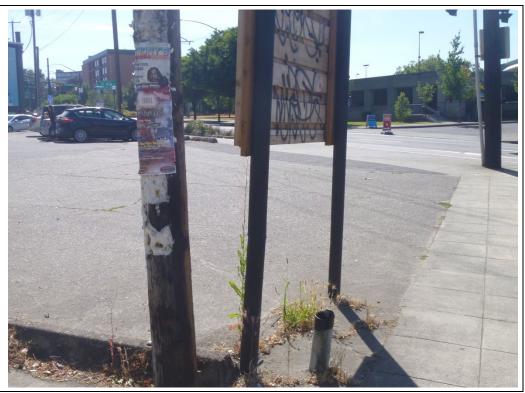
Photo No.Date:167/25/17Direction PhotoTaken:

View of undeveloped land at the intersection of N Williams and N Broadway, within the proposed ODOT Hancock/Dixon cover. I-5 is located east (left) and downgradient. This photo was taken within the Project Area.

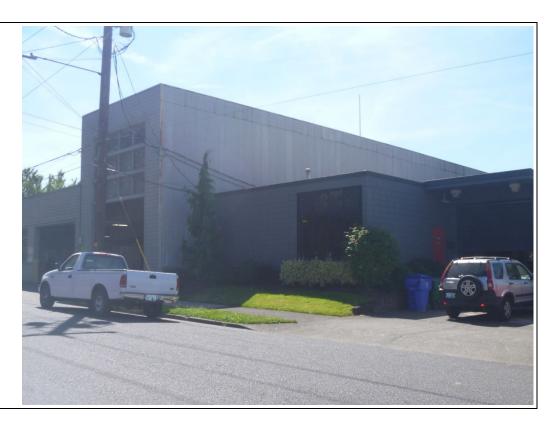
View of Site 6, observed operating as Seargent's Towing. This Site of Concern is within the Project Area and is ranked low priority.

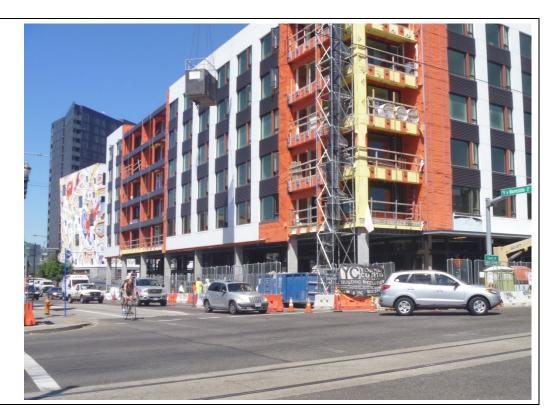
Photo No.Date:287/25/17Direction PhotoTaken:

View of NE Couch Street and SE Grand Avenue intersection. View of Site 136, "Stark's Inc" (107 NE Grand Avenue), to the north (right) and Site 144 to the south (left). Both Sites of Concern are outside the Project Area and are ranked low priority.
