Hazardous Materials Technical Report Oregon Department of Transportation

Appendix B. Field Survey Photo Log

Hazardous Materials Technical Memorandum, I-5 Rose Quarter Improvement Project Site Location: Portland, Oregon PHOTOGRAPH LOG

Project No. 60537425

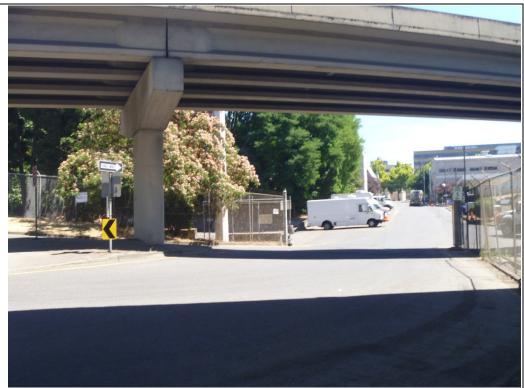
View of Site 47, beneath I-5. Fueling canopy is visible in the background to the right. This Site of Concern is located upgradient and within 1,000 feet of the Project Area and is ranked low priority.

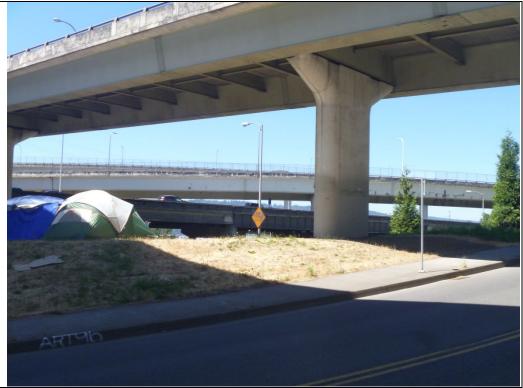
View of a vagrant camp along N Mississippi Avenue beneath I-5 (Fremont Bridge). This photo was taken outside and upgradient of the Project Area.
